## IMPORTANT SAFETY NOTICE 2

Concerning the first production Forza harnesses manufactured in 2015 with the serial numbers:

Forza-(size)-Q-31A-(???)

Forza-(size)-Q-49E-(???)

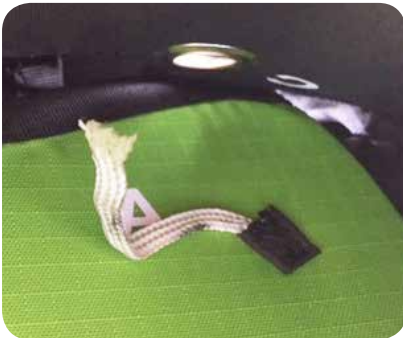
There have been several reported cases of a reserve loop failure on the Forza harness. In all cases, one of the loops holding the reserve pin failed completely. There have also been some reported failures of loops that had previously passed the safety notice checks at 15kgs. For this reason we are re-issuing this safety notice with more stringent check requirements (see below).

Due to the double pin design the failure of one loop should not pose an immediate risk of accidental deployment but it is strongly recommended that your loops are properly checked by your Ozone dealer or a qualified professional before attempting to fly the harness again.

Please return your harness to your dealer, or a qualified professional to perform the checks.
